Level 1 Supervision & Inspection Report

OLIVINE ESTATE STAGE 26

Prepared for Winslow Constructors Pty Ltd

28 August 2025

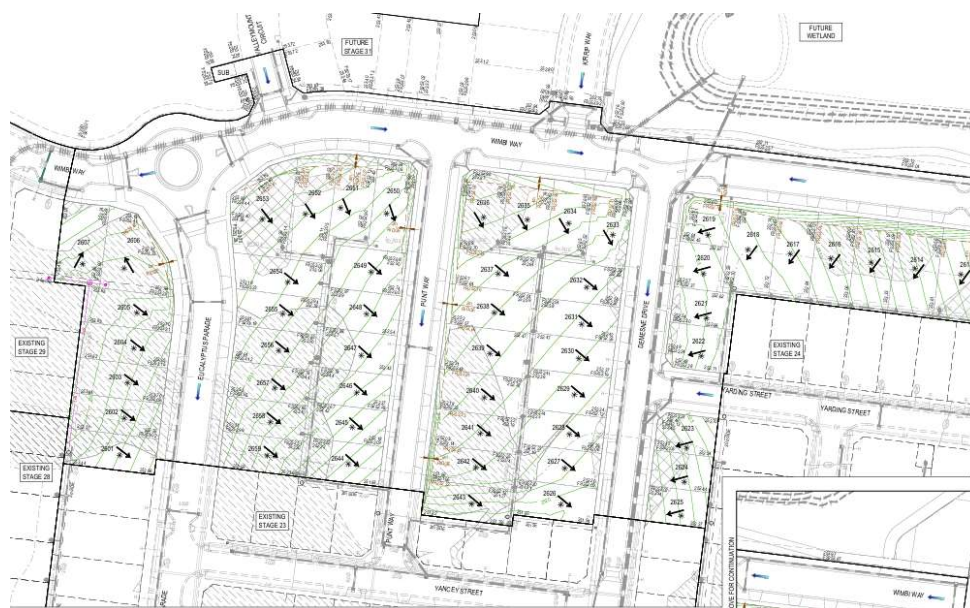
Figure 1. Level 1 supervision fill areas highlighted

The approximate location of the site is shown outlined in figure 1 below:

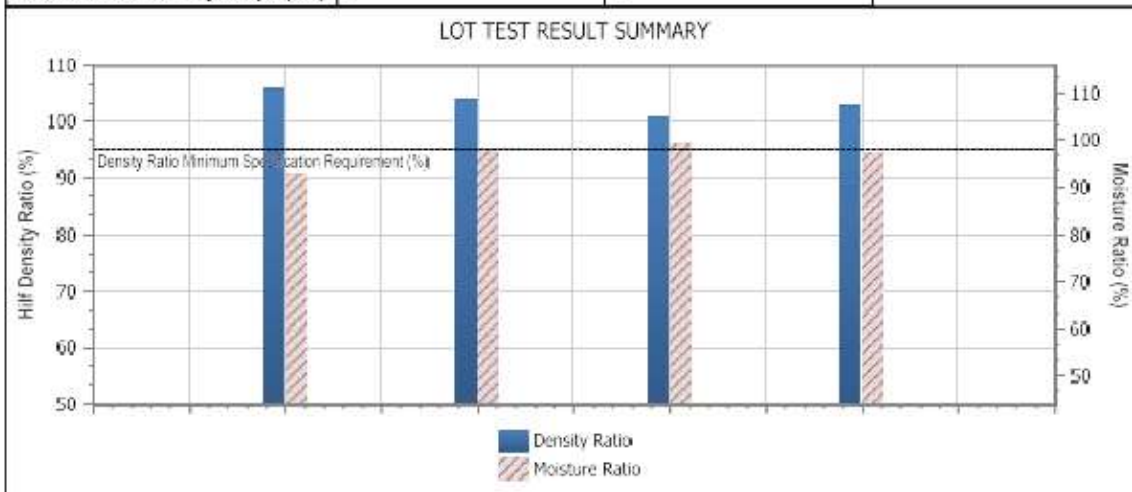
Tests in Lot = 4	Lot Minimum	Lot Maximum	Lot Mean	Standard Deviation
Moisture Ratio (%)	92.9	99.2	96.7	2.692
Half Density Ratio (%)	101.0	105.8	103.4	1.997

Lot Number:	n/a
Mean Moisture Ratio (%):	96.7
Mean Density Ratio (%):	103.4

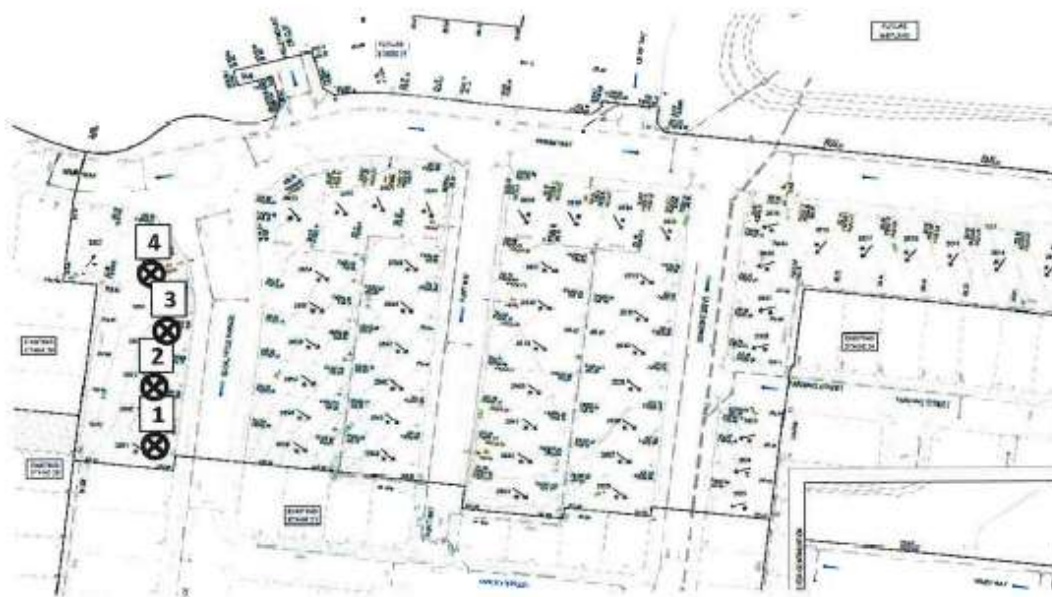
Site Location Sketch

Test site locations only
NOT TO SCALE

Test Request No. T/
Date Tested: 07/08/2025

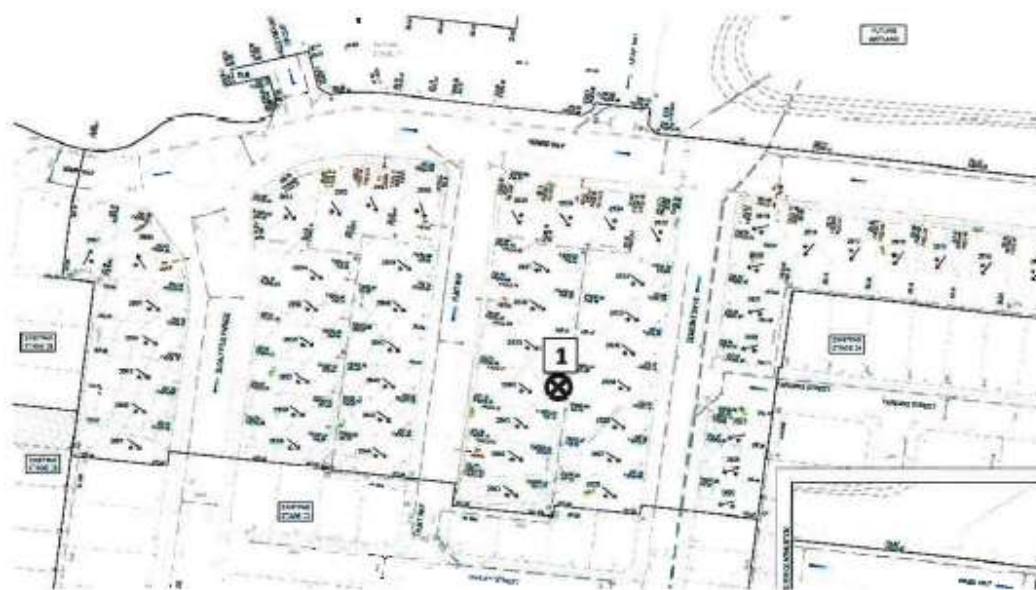
Site Location Sketch

Test site locations only
NOT TO SCALE

Client: Winslow Constructors
Job No. P/3155
Test Request No. T1
Date Tested: 12/08/2025

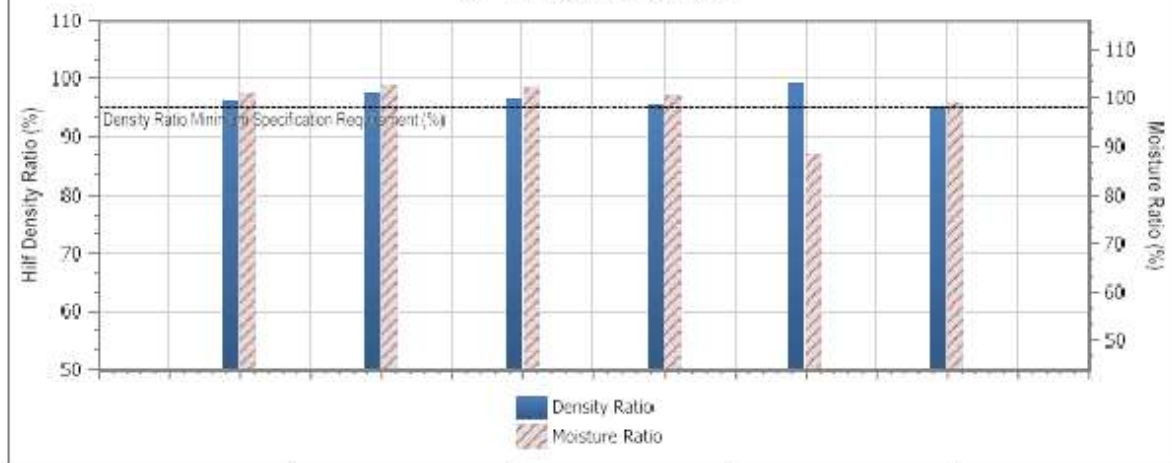
LOT TEST RESULT SUMMARY

Tests in Lot = 6	Lot Minimum	Lot Maximum	Lot Mean	Standard Deviation
Moisture Ratio (%)	88.3	102.4	98.9	5.341
Hill Density Ratio (%)	95.1	99.1	96.6	1.484

Lot Number:	n/a
Mean Moisture Ratio (%):	98.9
Mean Density Ratio (%):	96.6

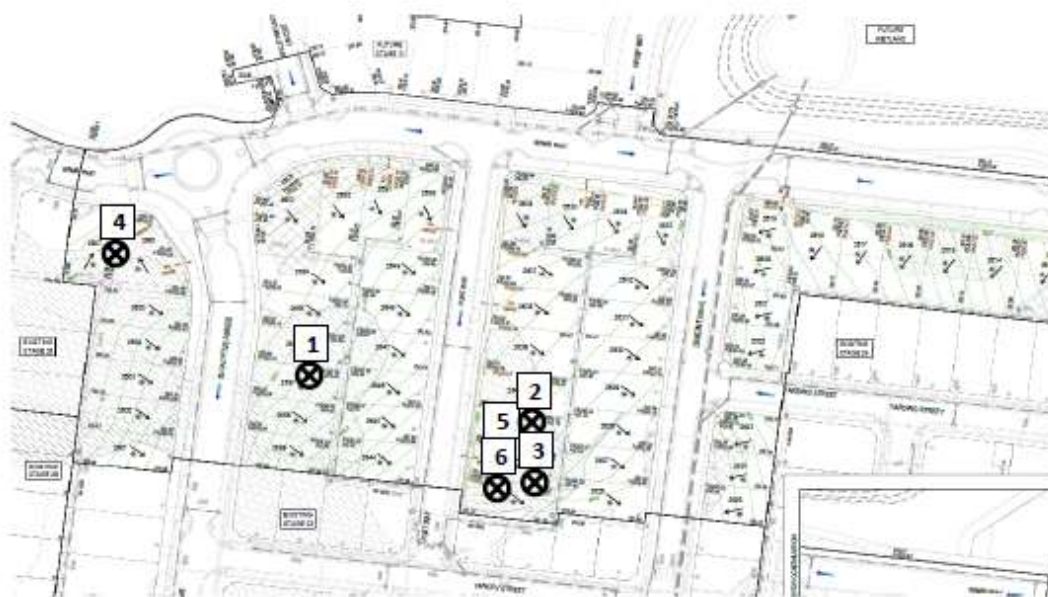
Site Location Sketch

Client: Winslow Constructors
Job No. P/3155
Test Request No. T/
Date Tested: 14/08/2025

Test site locations only
NOT TO SCALE
